TIMS E-NEWS

The International Molinological Society

Fall/ Winter 2023

Issue 35

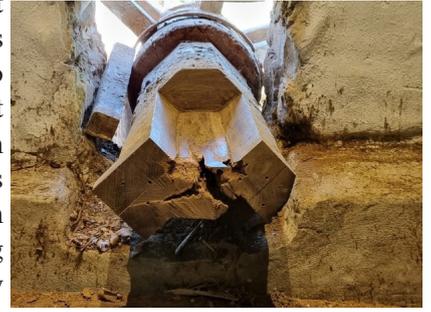
My idea for the axle tree was for Jon to cut back the burnt piece to where there was more or less the full dimensions, then to cut away two opposite quarters beyond that point. He was then to make up the extension out of four quarters, two opposite ones longer than the others so there would be an overlap. He did better than this, by leaving a core at 45 degrees in the middle, thereby increasing the contact area for glueing.

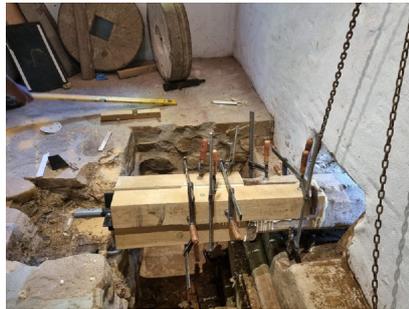
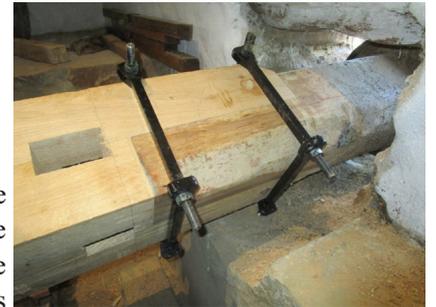
We made two sets of interlocking eye-bolts over the 'splice' and two more over the four bladed gudgeon he set in the end.

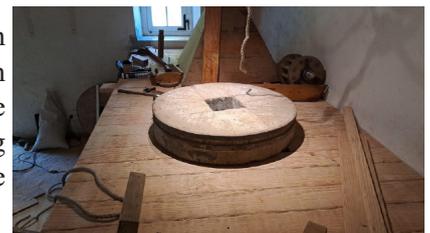
The original neck bearing was worm-eaten and the hole was worn out, nor did it match the new stone spindle. I made a new square of wood, forced it in and made up a boring spindle and bored it perpendicular to the grinding face.

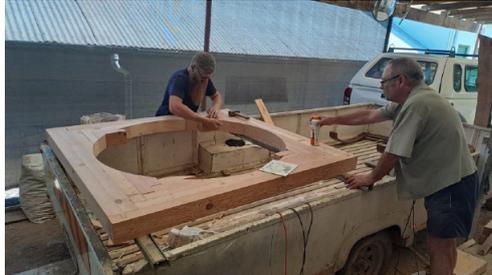
Detail of the corners. NO nails or screws, dowels they have made with the same wood!

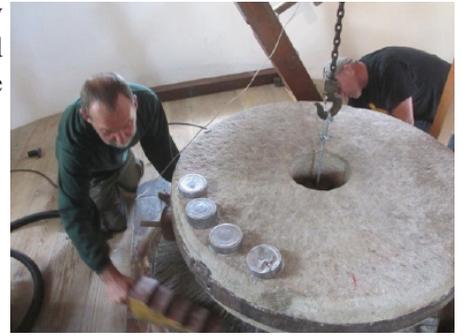
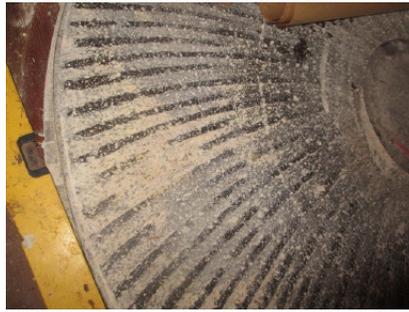
Here the runner is hanging on a dummy cock-head with the cable attached dead centre. We had to add 20kg of lead to the top to make it balance!

To the dressing: At some stage the bedstone must have been replaced with one of a different material and with sickle dressing, where the runner had harps. This was not an ideal combination and when we had the stones open, first to level the bedstone, then to balance, at least statically, the runner we made a snap decision to cut harps over the sickles on the bedstone. We made a template of the dressing off the upturned runner and replicated that on the bedstone.

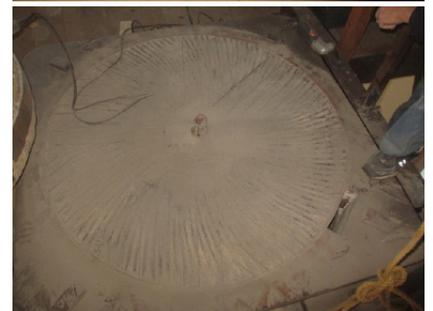
One harp cut, vertical edge only.

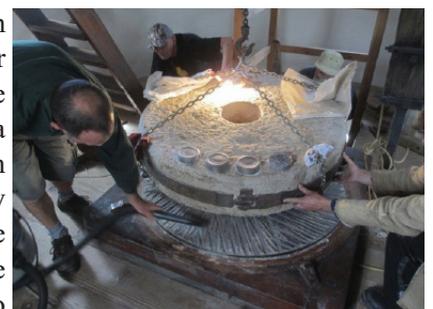
Here you can see we are closing the now balancing runner over the bedstone with both styles of dressing.

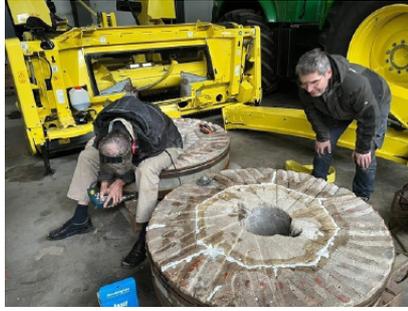
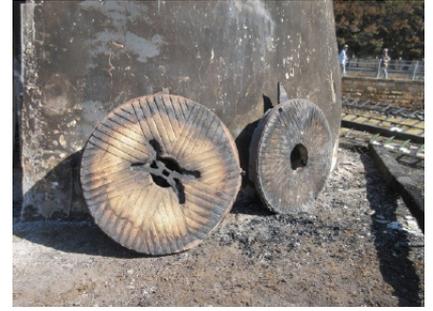
Incidentally, this is how they looked after we rolled them out of the ashes, the bedstone on the right showing the harps prominently.

We had no cause to open the stones again and in the fire they fell from the stone floor and the bedstone was badly broken, the runner is cracked, so we're settling for a pair of second-hand French Burrs which worked at a watermill in Barcelona. They are harp-dressed and our supporters in the Netherlands are making sure that by the time they arrive here all we have to do is to install them!

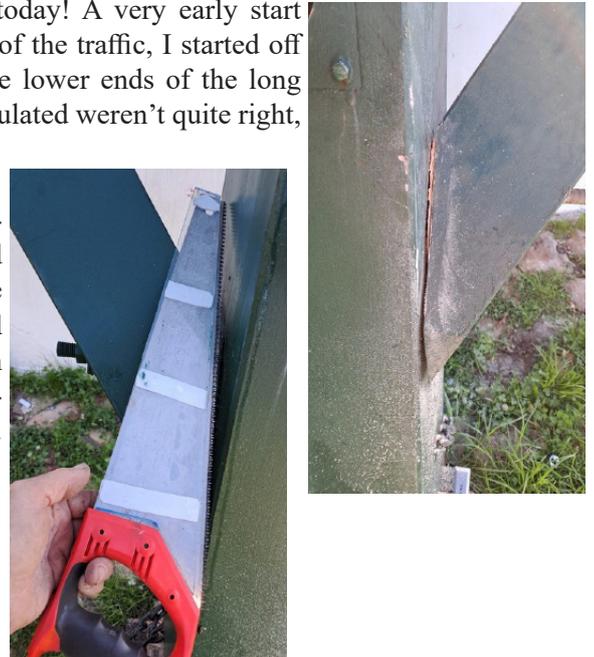
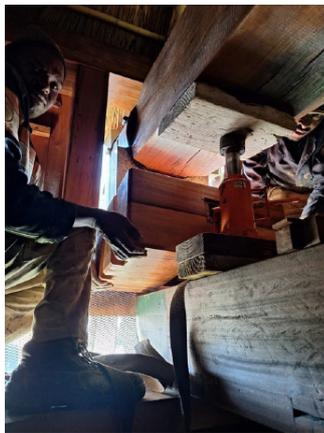
I had cut a piece of poly-propylene (like perspex) and attached it to one side of the saw with thin double-sided tape to hold the blade a certain distance away from the tailpole and to avoid damaging it.

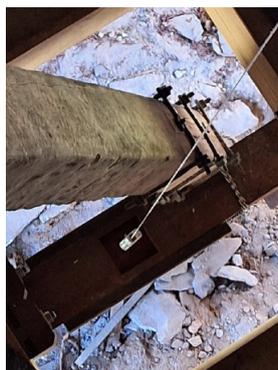
It was a relief to see the plumb bob dead centre in the socket for the footstep!

From the plumb line we also found the exact position for the footstep bearing, a cast-iron square with a recess for a dome washer. I deliberately made the socket slightly bigger than the square, to allow for adjustment and wedging/spacing during trammeling. I started with a chisel and quickly gave up and did the job on the Multico mortiser!

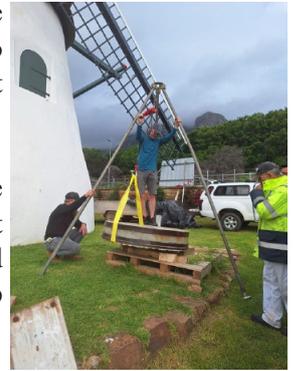
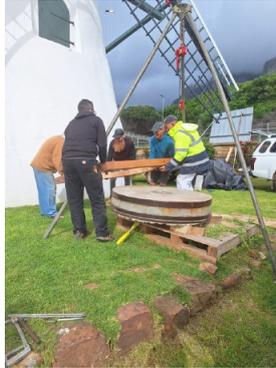
Testing the curb over the up-turned bedstone.

We found in fact we have some clearance.
